**Flood Control Project Maintenance  
Levee Inspections  
LMA District Cover Sheet  
Spring 2010 Levee Inspection Results**

**Reclamation District No. 0554 Walnut Grove**

**Levee Inspection Report By Mile - Spring 2010**

Waterway						Bank	Unit Miles	Inspection Start/End	Inspector	
Unit No. 01 Sacramento River						Left	1.09	04/08/2010 04/08/2010	Herman Phillips	
LMR No	Levee Mile		Category	Item	Location	Rating	Action/Comment	GPS Latitude/Longitude		Issue No. Photo
	Start	End						Start	End	
1	0.05	0.17	Earthen Levee	Vegetation	WS	M	Control annual grass and weeds on the levee slopes and easements.	38.248870 ° -121.510005 °	38.247162 ° -121.510122 °	10 Y
2	0.25	0.34	Supplemental	USACE Erosion Survey	WS	U	Inspector Comments: 2009: 2 ft berm, 1.5:1 slope, tension cracks, tree hazards, holes and slumping, clays and silts, 6.23 ft/s [2009 SiteID:SAC_27-0_L]	38.246183 ° -121.510797 °	38.245017 ° -121.511742 °	16 Y
3	0.28	0.33	Earthen Levee	Vegetation	WS	M	Control annual grass and weeds on the levee slopes and easements.	38.245677 ° -121.511045 °	38.245117 ° -121.511392 °	11
4	0.29	0.29	Earthen Levee	Trim / Thin Trees	LS	M	Trim trees to at least five feet above ground level.	38.245530

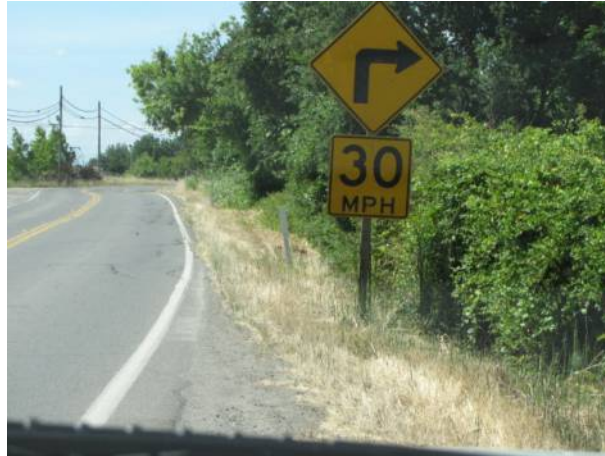
Levee Mile Report Line	1
Start Levee Mile	0.05
End Levee Mile	0.17
Location	Water Side
Category	Earthen Levee
Item	Vegetation

Photo taken here of the waterside looking downstream from levee mile 0.00

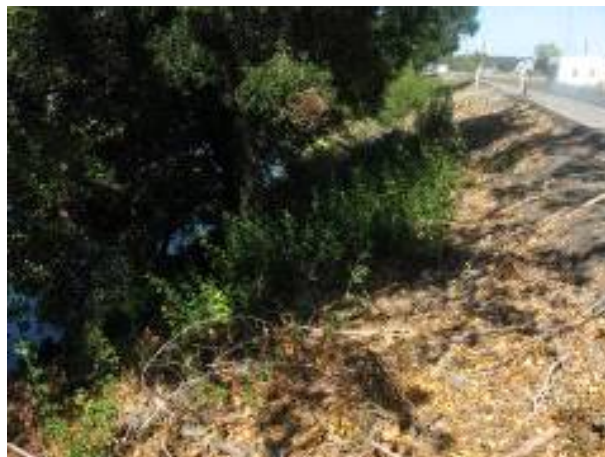
Levee Mile Report Line	2
Start Levee Mile	0.25
End Levee Mile	0.34
Location	Water Side
Category	Supplemental
Item	USACE Erosion Survey

2009: 2 ft berm, 1.5:1 slope, tension cracks, tree hazards, holes and slumping, clays and silts, 6.23 ft/s [2009 SiteID:SAC\_27-0\_L]

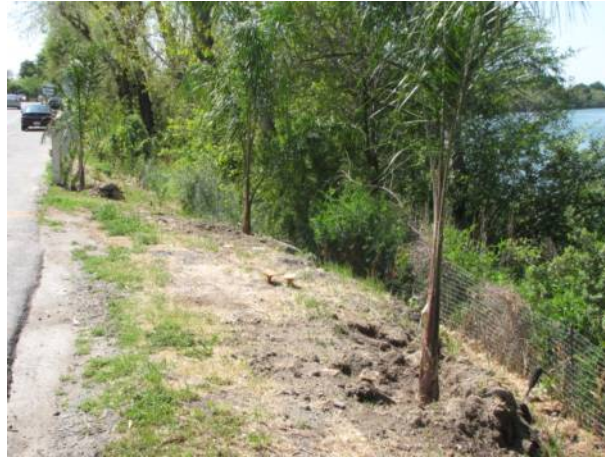
Levee Mile Report Line	8
Start Levee Mile	0.69
End Levee Mile	0.69
Location	Water Side
Category	Earthen Levee
Item	Encroachments

This photo shows the unauthorized trees planted on water ward shoulders. 38.240735-121.515137 levee mile 0.69 facing downstream standing on water side.

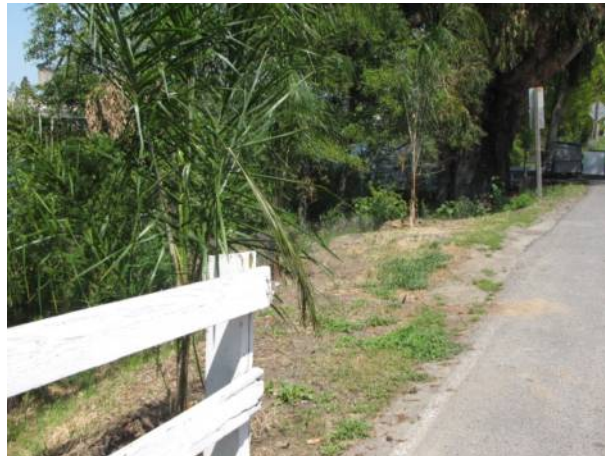
Levee Mile Report Line	8
Start Levee Mile	0.69
End Levee Mile	0.69
Location	Water Side
Category	Earthen Levee
Item	Encroachments

Standing downstream on waterside looking upstream at unauthorized planting of trees on shoulder.
